STEEPLE ASTON VILLAGE ARCHIVE

Grange Farm House - Reconstructing its past

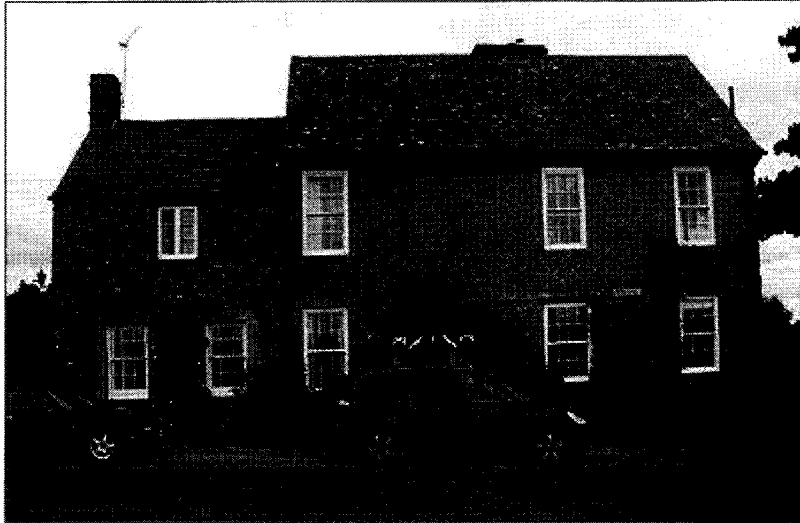
This article focuses on the front range of the current house (shown left), which faces due south and consists of two distinct sections, a larger eastern section, with a smaller, later, extension to the west.

Close inspection of the front wall at ground level shows this to be continuous across the facade, with identical quoins on each end. By contrast, there is clear evidence of rebuilding on top of earlier stonework on the gable end and the rear wall of the lower extension. Visible high up on the western gable end of the roof of the taller section are the cut ends of the purlins (the long

timbers that traverse the length of the roof). This all suggests the original house occupied the same footprint as now but with a uniform height across the structure.

The front elevation of the taller range shows evidence that the windows have been rearranged, the previous arrangement consisting of a window above the front door with 3 windows to its right on each storey. In the attic, the timbers of the front slope of the roof show evidence of previous dormer windows, one over the front door and another over the original 2nd bay (these locations having no pegs in the purlin-rafter joints). The straight gable end, rather than a hipped roof, dates the original house to around 1720. Houses of this period usually exhibited a high degree of symmetry so this arrangement would be expected to be mirrored to the left of the front door. This would have resulted in the original house having an impressive 7-bay frontage with 3 dormer windows, and two large chimneys. My re-creation of how this may have looked is shown below.

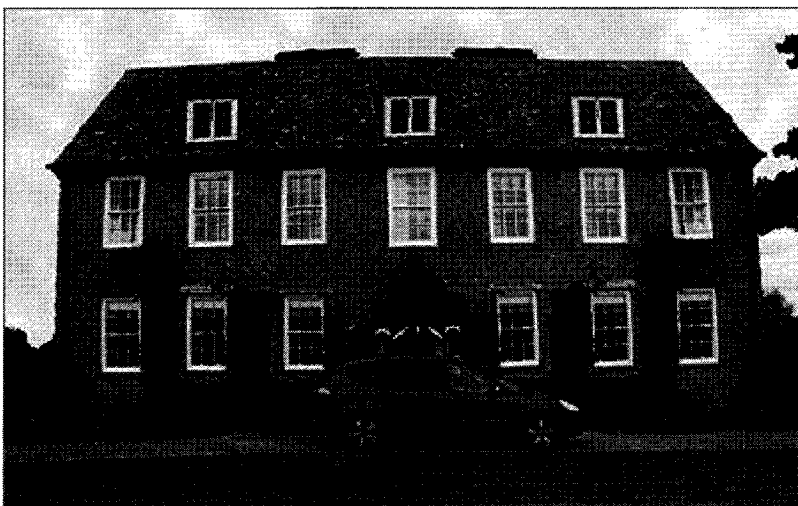
What caused the house to be altered so much? The rebuilt stonework in the lower section suggests a possible disaster befell this part of the house. There is no evidence of a fire so a collapse of the structure seems more likely, possibly from subsidence. There is evidence elsewhere to support this. The second chimney may well have fallen in such a collapse. After loss of such a large section of the house, it appears the owners remodelled the structure to make best use of the remaining space, moving windows to reflect their internal changes. The western end was rebuilt at a later date (somewhere in

the period 1780-1840). We concluded that the structural disaster probably occurred quite early in the history of this interesting house.
